Mechanical Breakdown Inspection Report

Customer Complaints on Repair Order	TRANSMISSION IS SLIPPING. CEL ON.

Yr/Mk/Mdl:	<input type="text" value="2004 FORD EXPLORER"/>	Mileage:	<input type="text" value="72,140.00"/>
VIN	<input type="text" value="1FMZU75W342A54195"/>	Production Date	<input type="text" value="01/04"/>
Engine size	<input type="text" value="4.6"/>	Fuel Type	<input type="text" value="Gasoline"/>
Trans. Type	<input type="text" value="Automatic"/>	Drive Type	<input type="text" value="FWD"/>

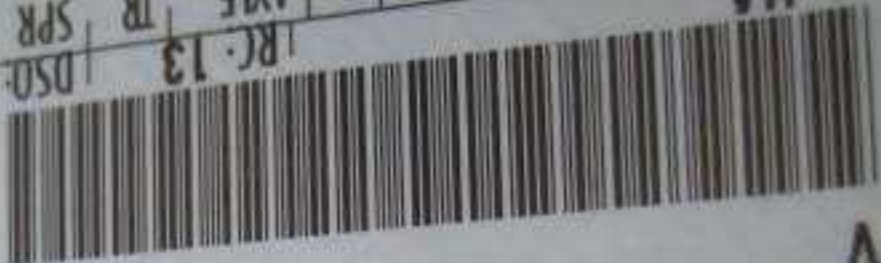
VIN: 1FMZU75W34ZA54195
 TYPE: MPV

THIS VEHICLE CONFORMS TO ALL APPLICABLE FEDERAL MOTOR VEHICLE SAFETY AND THEFT PREVENTION STANDARDS IN EFFECT ON THE DATE OF MANUFACTURE SHOWN ABOVE.

MFD. BY FORD MOTOR CO. IN U.S.A.
 DATE: 01/04
 FRONT GAWR: 2800LB
 REAR GAWR: 3325LB
 1270KG
 P245/65R17
 17X7.5J
 AT 240 kPa/35
 WITH
 TRES
 RIMS
 PSI COLD
 1508KG
 P245/65R17
 17X7.5J
 AT 240 kPa/35
 WITH
 TRES
 RIMS
 PSI COLD

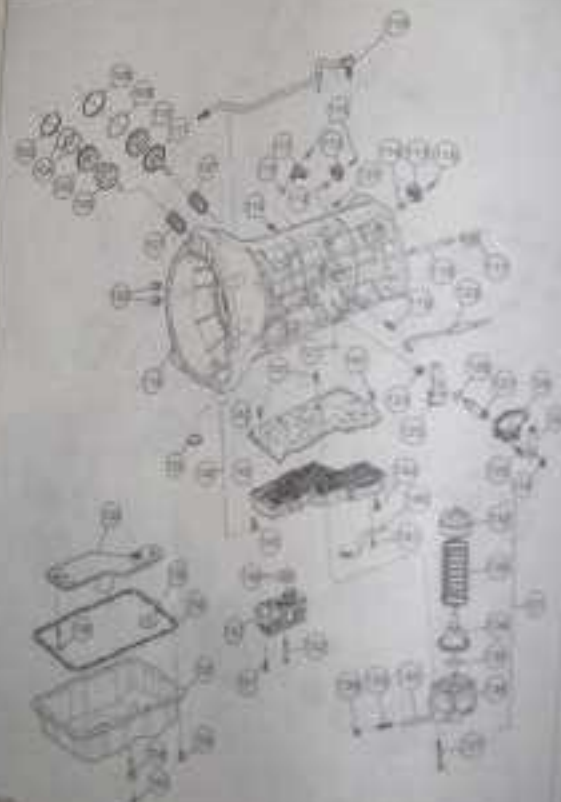
DESCRIPTION AND OPERATION (Continued)

Automatic Case (Continued)
